Conditions of Fukushima Dai-ichi Nuclear Power Station Unit 1

# Conditions of Fukushima Dai-ichi Nuclear Power Station Unit 2 (As of 06:00 March 26th, 2011)

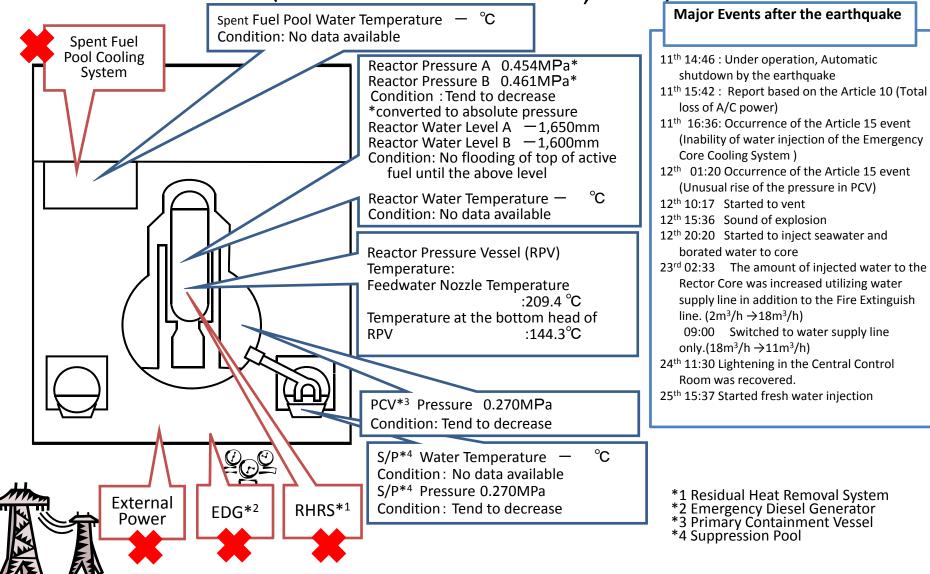
Current Conditions: Fresh water is being injected to the core

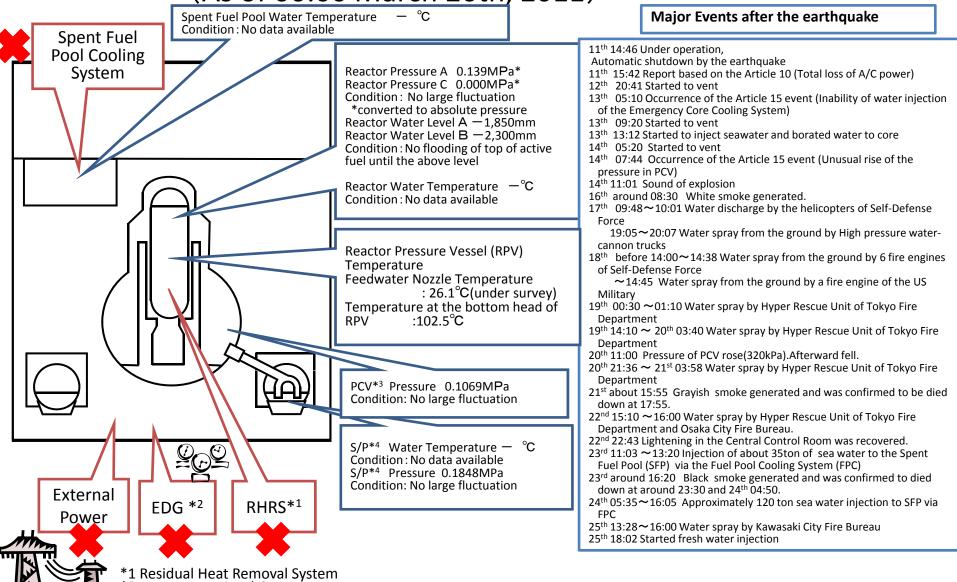
#### Conditions of Fukushima Dai-ichi Nuclear Power Station Unit 3

Current Conditions: Sea water is being injected to Spent Fuel Pool and fresh water is being injected to the core

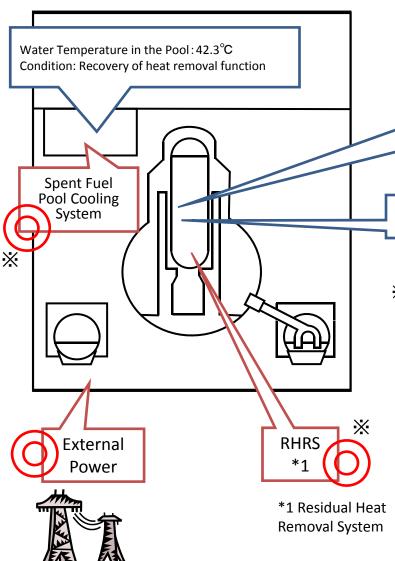
# Conditions of Fukushima Dai-ichi Nuclear Power Station Unit 5 (As of 06:00 March 26th, 2011)

Reactor Pressure: 0.108MPa\*
Reactor Water Level: 2,130mm
Reactor Water Temperature: 30.3°C
Condition: Pressure is under control.
\*converted to absolute pressure

Reactor Pressure Vessel Temperature: Monitoring by Reactor Water Temperature

23<sup>rd</sup> 17:24 Pump for Residual Heat Removal Seawater System (RHRS) was automatically stopped when the power supply was switched from the temporary to the permanent.

24th 16:14 Repair of the RHRS pump was completed.

24th 16:35 Cooling started.
