Conditions of Fukushima Dai-ichi Nuclear Power Stations **Unit 1**

(As of 14:00 March 18th, 2011)

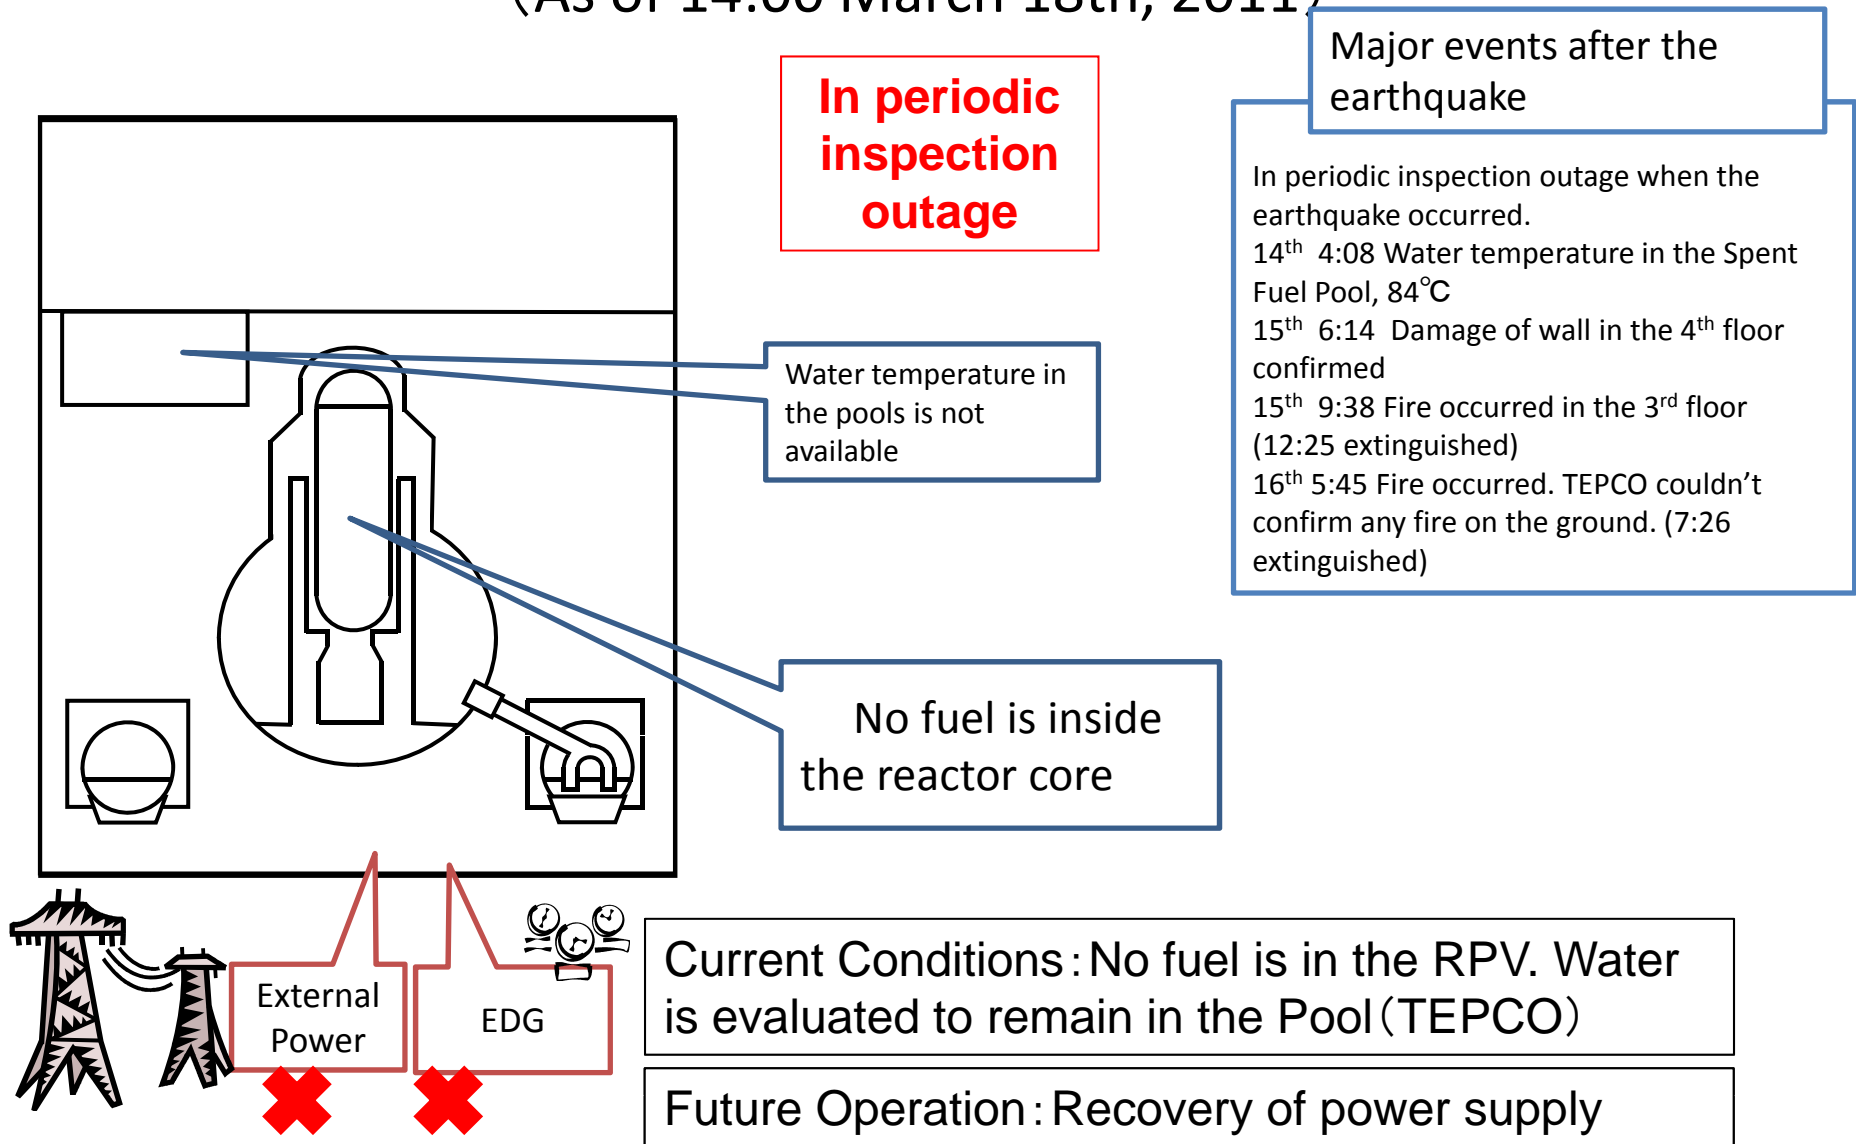
Conditions of Fukushima Dai-ichi Nuclear Power Stations **Unit 4** (As of 14:00 March 18th, 2011)

In periodic inspection outage when the earthquake occurred.

14th 4:08 Water temperature in the Spent Fuel Pool, 84°C

15th 6:14 Damage of wall in the 4th floor confirmed

15th 9:38 Fire occurred in the 3rd floor (12:25 extinguished)

16th 5:45 Fire occurred. TEPCO couldn't confirm any fire on the ground. (7:26 extinguished)

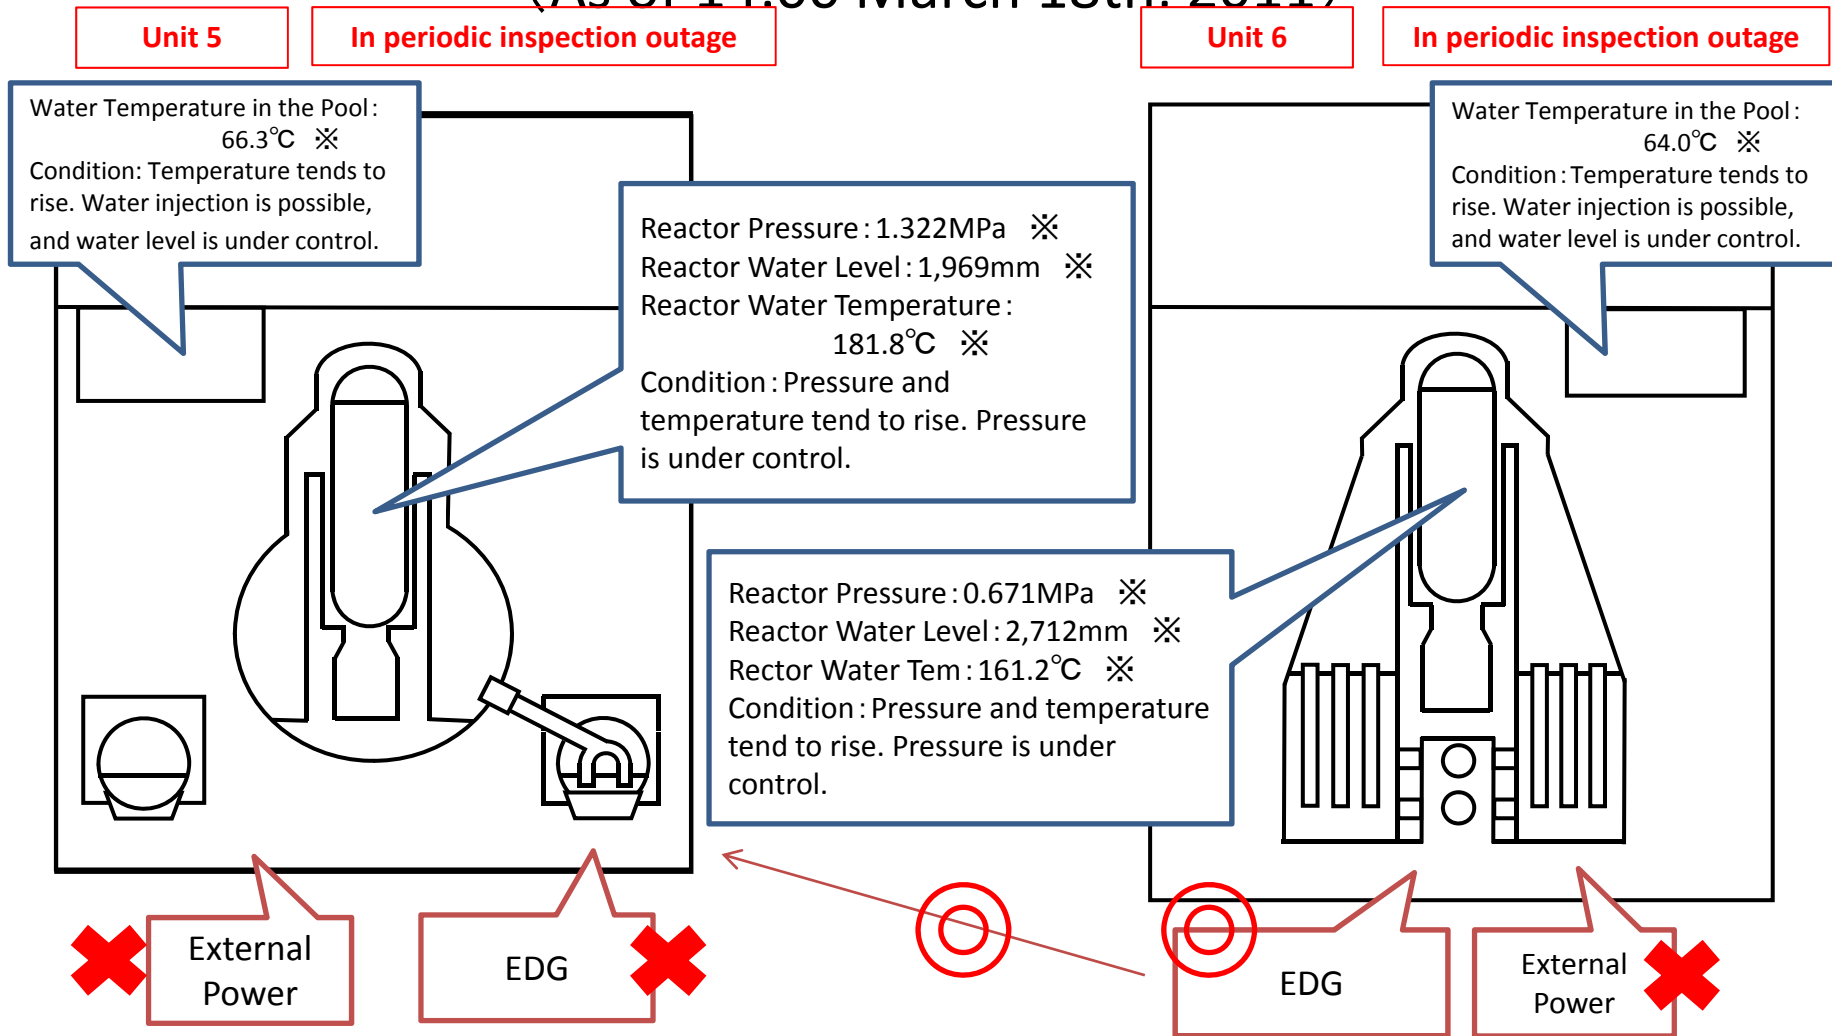
Conditions of Fukushima Dai-ichi Nuclear Power Stations Unit 5/6 (As of 14:00 March 18th, 2011)

Current Conditions: Emergency Diesel Generator (1 unit) for Unit 6 is being operated (supplying electricity to Units 5 and 6)

Future Operation: Start operating for recovery of external power
