The Fukushima Daiichi Incident

1. Plant Design
2. Accident Progression
3. Radiological releases
4. Spent fuel pools
5. Sources of Information

Matthias Braun
PEPA4-G, AREVA–NP GmbH
Matthias.Braun@AREVA.com

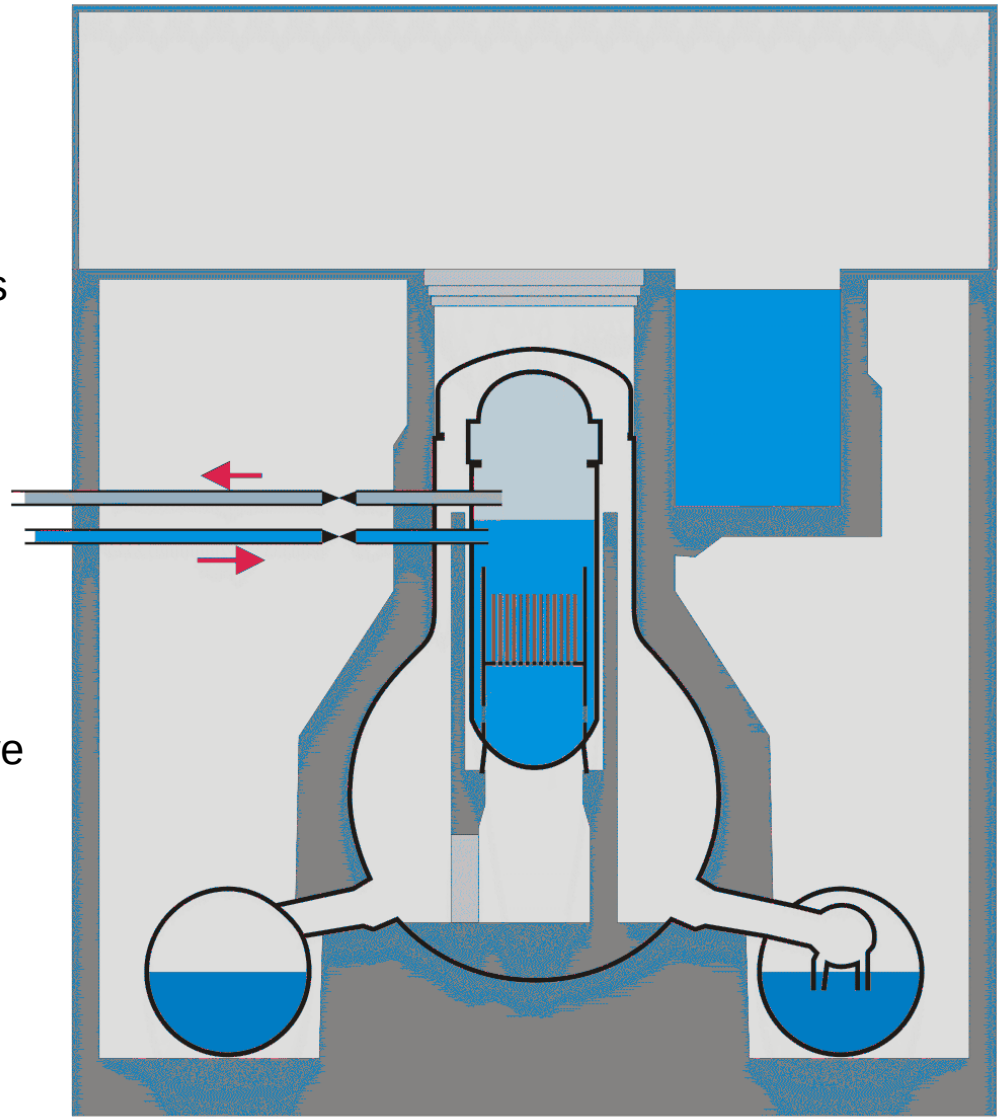
- 11.3.2011 14:46 - Earthquake
  - Magnitude 9
  - Power grid in northern Japan fails
  - Reactors itself are mainly undamaged
- SCRAM
  - Power generation due to Fission of Uranium stops
  - Heat generation due to radioactive Decay of Fission Products
    - After Scram ~6%
    - After 1 Day ~1%
    - After 5 Days ~0.5%

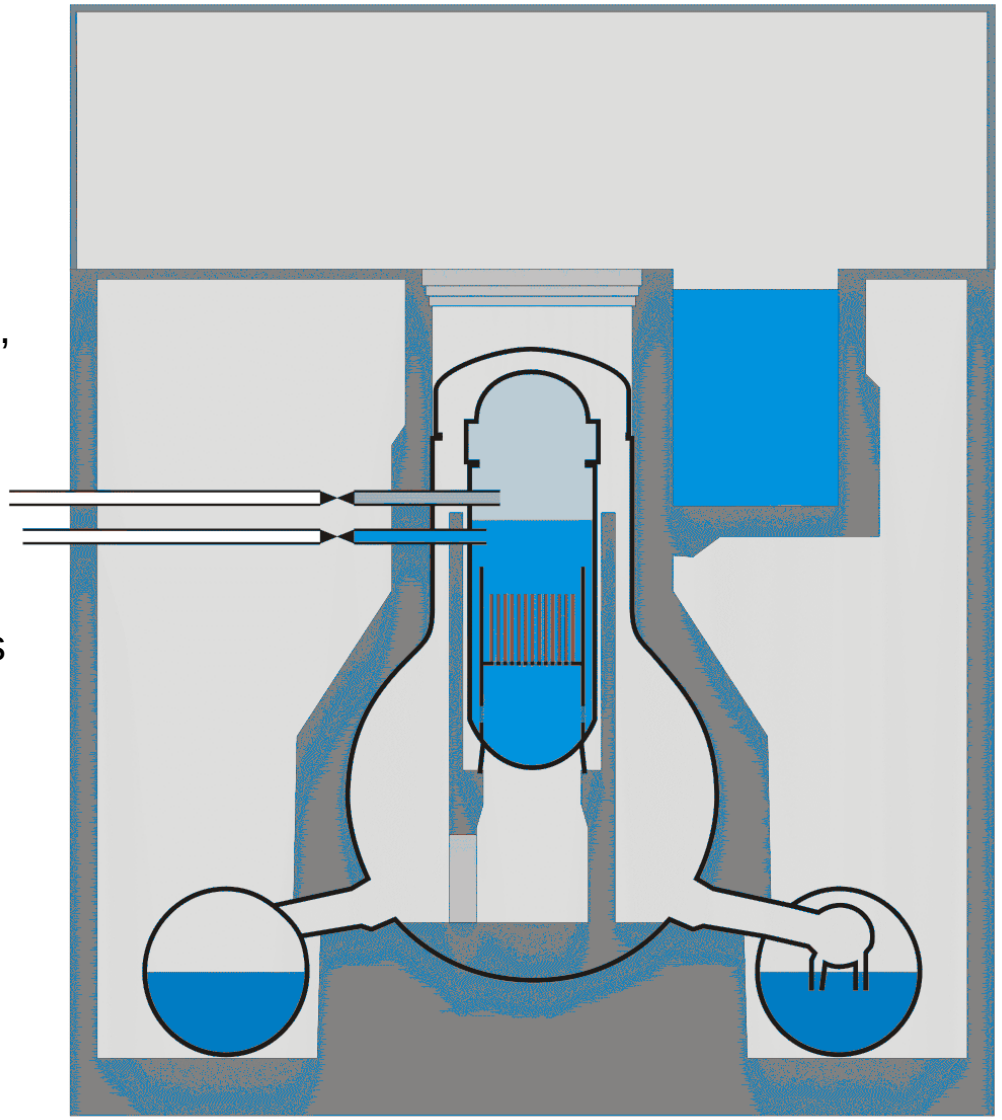
- Containment Isolation
  - Closing of all non-safety related Penetrations of the containment
  - Cuts off Machine hall
  - If containment isolation succeeds, a large early release of fission products is highly unlikely
- Diesel generators start
  - Emergency Core cooling systems are supplied
- Plant is in a stable save state

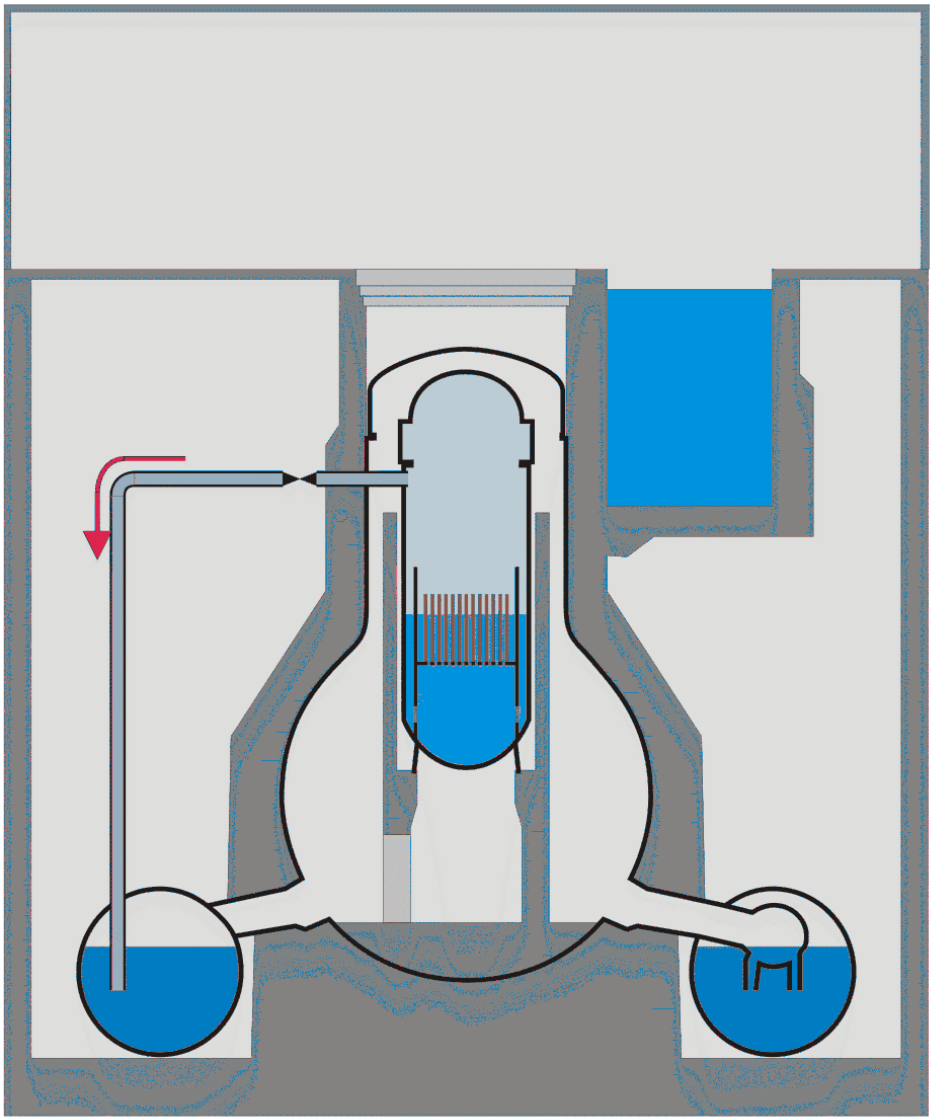
- Reactor Isolation pump stops
  - 11.3. 16:36 in Unit 1 (Batteries empty)
  - 14.3. 13:25 in Unit 2 (Pump failure)
  - 13.3. 2:44 in Unit 3 (Batteries empty)
- Decay Heat produces still steam in Reactor pressure Vessel
  - Pressure rising
- Opening the steam relieve valves
  - Discharge Steam into the Wet-Well
- Descending of the Liquid Level in the Reactor pressure vessel

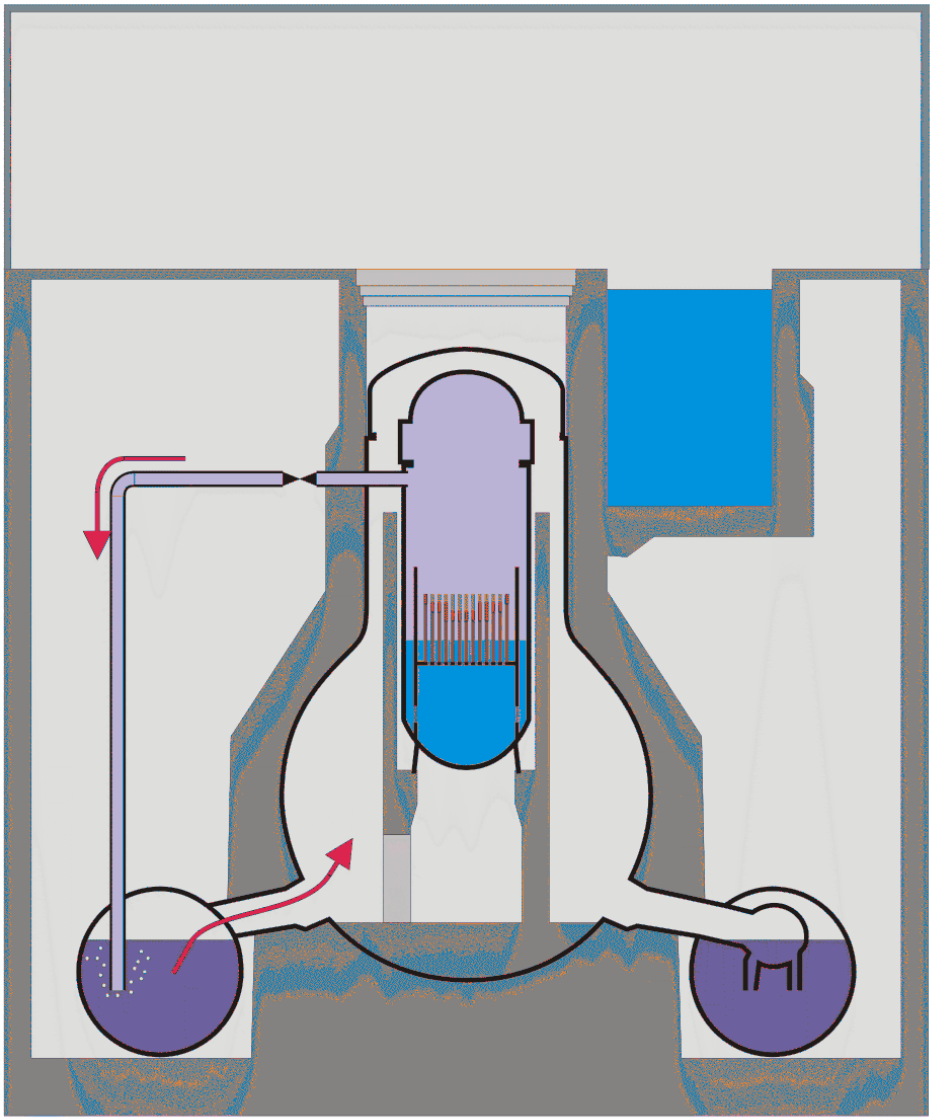
- ~3/4 of the core exposed
  - Cladding exceeds ~1200℃
  - Zirconium in the cladding starts to burn under Steam atmosphere
  - **$Zr + 2H_20 \rightarrow ZrO_2 + 2H_2$**
  - Exothermal reaction further heats the core
  - Generation of hydrogen
    - Unit 1: 300-600kg
    - Unit 2/3: 300-1000kg
  - Hydrogen gets pushed via the wet-well, the wet-well vacuum breakers into the dry-well

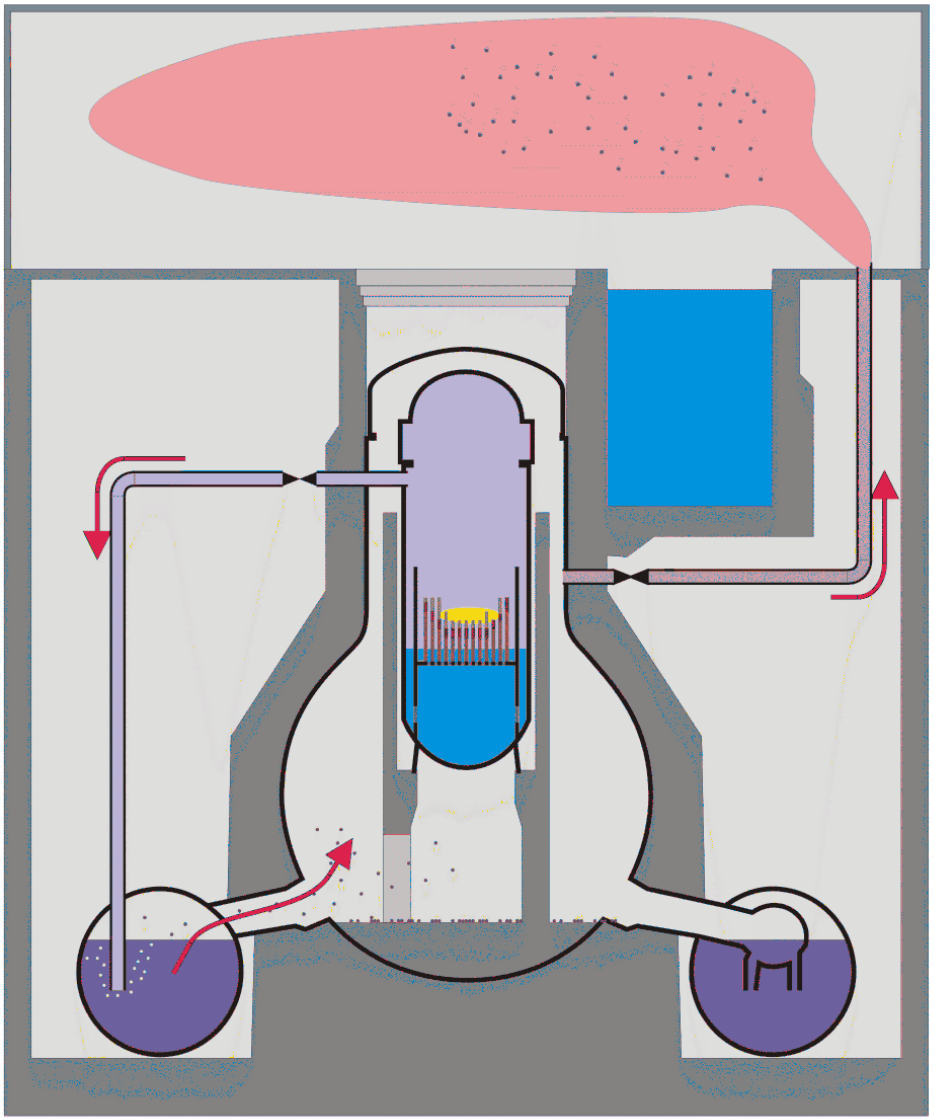
- Positive und negative Aspects of depressurizing the containment
  - Removes Energy from the Reactor building (only way left)
  - Reducing the pressure to ~4 bar
  - Release of small amounts of Aerosols (Iodine, Cesium ~0.1%)
  - Release of all noble gases
  - Release of Hydrogen
- Gas is released into the reactor service floor
  - Hydrogen is flammable

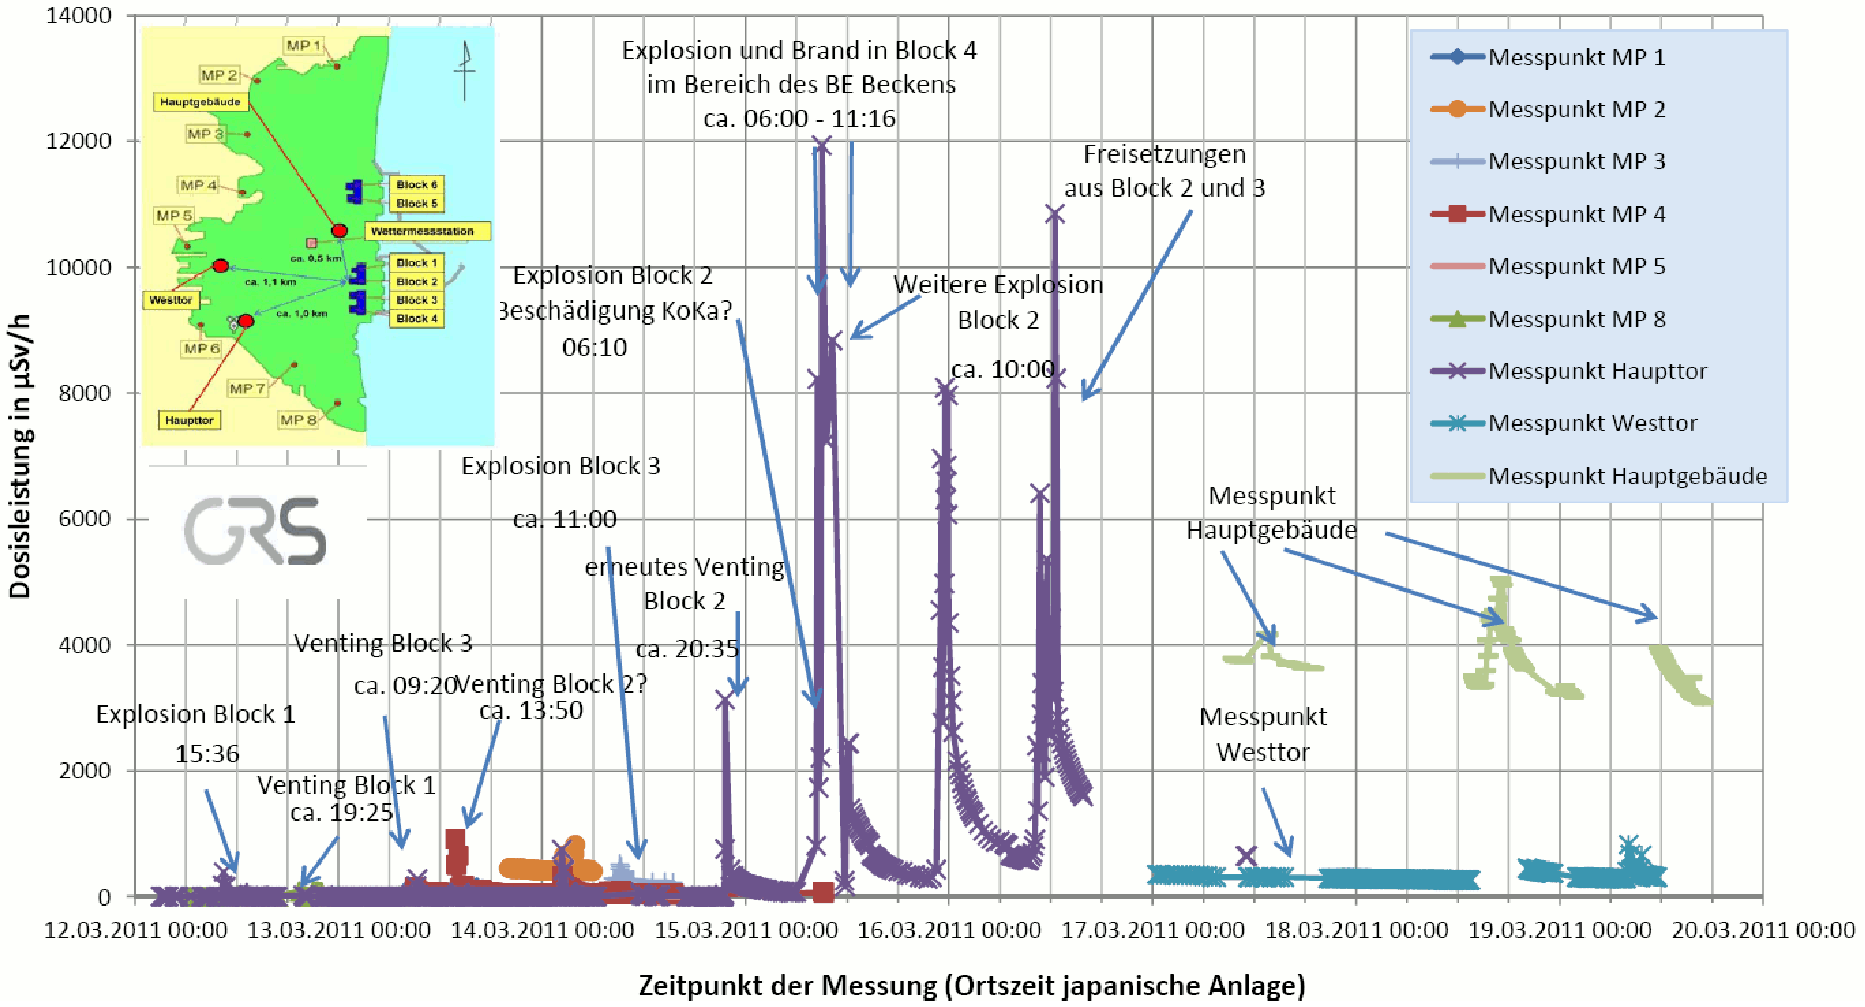
- Directly on the plant site
  - Before Explosion in Unit Block 2
    - Below 2mSv / h
    - Mainly due to released radioactive noble gases
    - Measuring posts on west side. Maybe too small values measured due to wind
  - After Explosion in Unit 2 (Damage of the Containment)
    - Temporal peak values 12mSv / h
    - (Origin not entirely clear)
    - Local peak values on site up to 400mSv /h (wreckage / fragments?)
    - Currently stable dose on site at 5mSv /h
    - Inside the buildings a lot more
  - Limiting time of exposure of the workers necessary
