Conditions of Fukushima Dai-ichi Nuclear Power Station Unit 1

# Conditions of Fukushima Dai-ichi Nuclear Power Station Unit 2 (As of 06:00 March 26th, 2011)

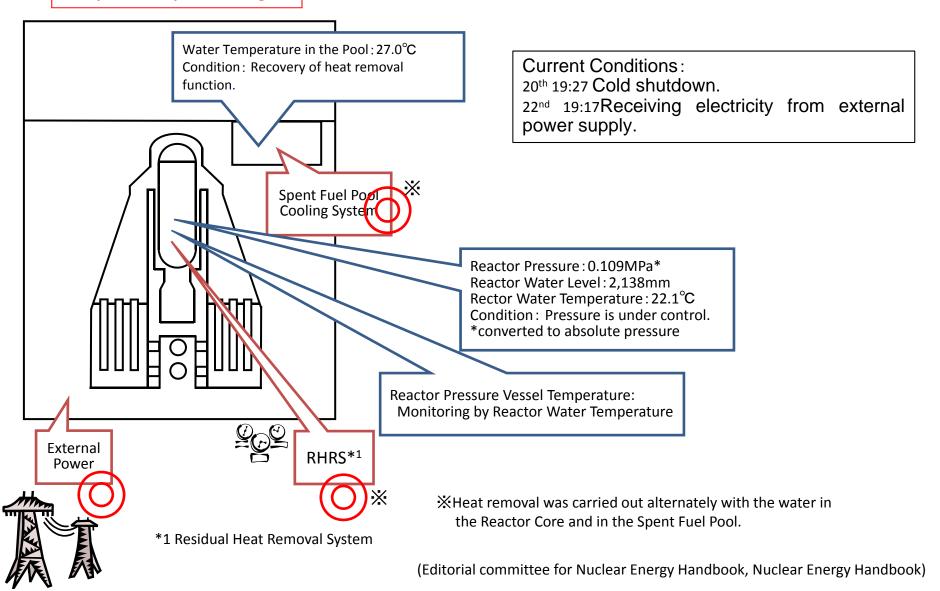
## Conditions of Fukushima Dai-ichi Nuclear Power Station Unit 6 (As of 06:00 March 26th, 2011)

In periodic inspection outage
